QUINNIPIAC RIVER BASIN
WOODBIDGE, CONNECTICUT

LAKE WATROUS DAM
CT 00318

PHASE I INSPECTION REPORT
NATIONAL DAM INSPECTION PROGRAM

AUGUST 1978

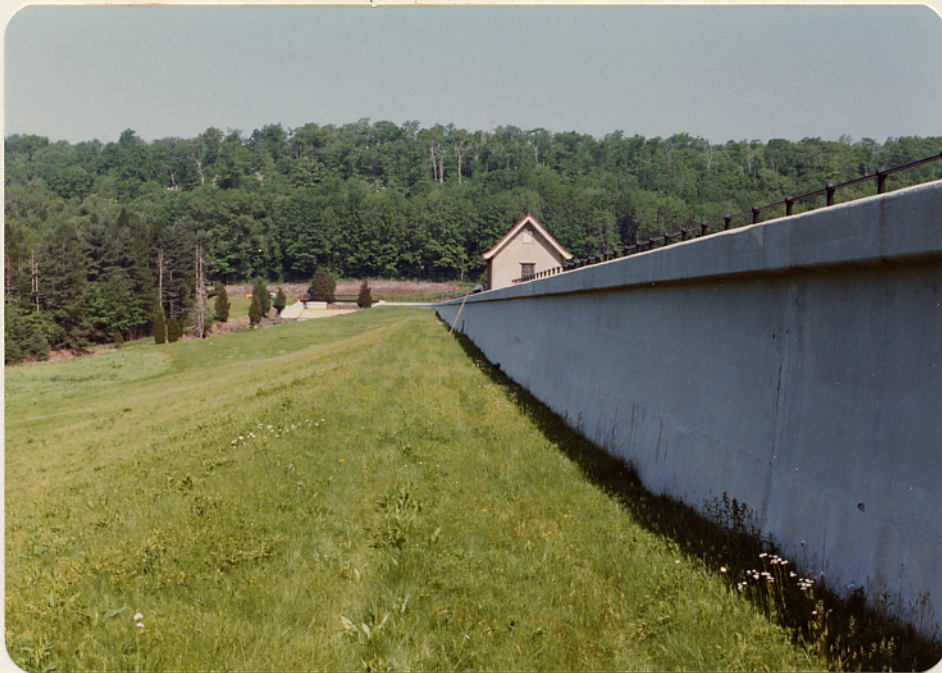
PHOTO NO.1 - General view of downstream face of dam and embankment.

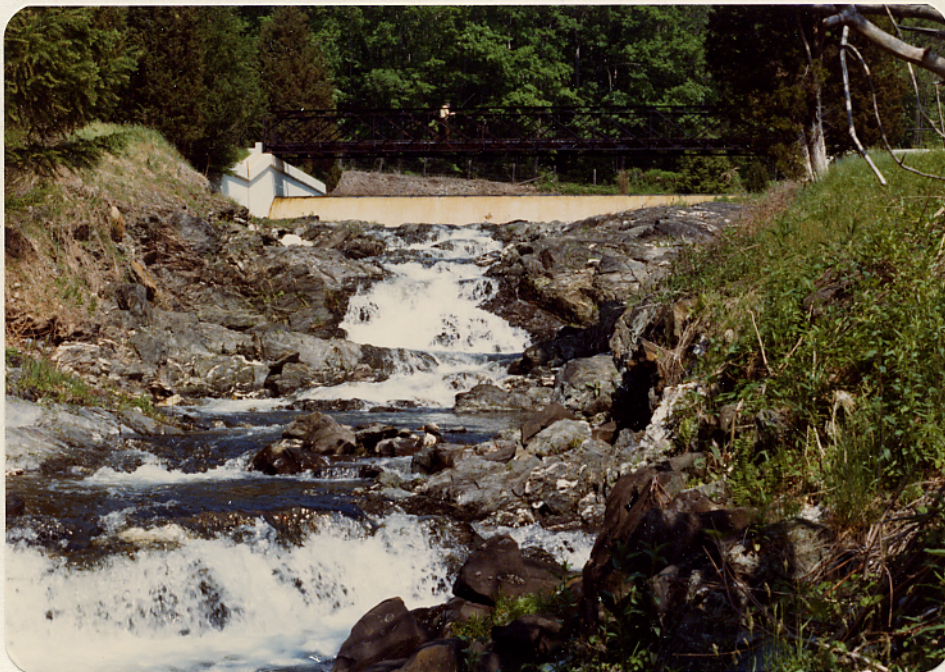
PHOTO NO.2 - Spillway, bridge, and channel cut into natural rock formation.

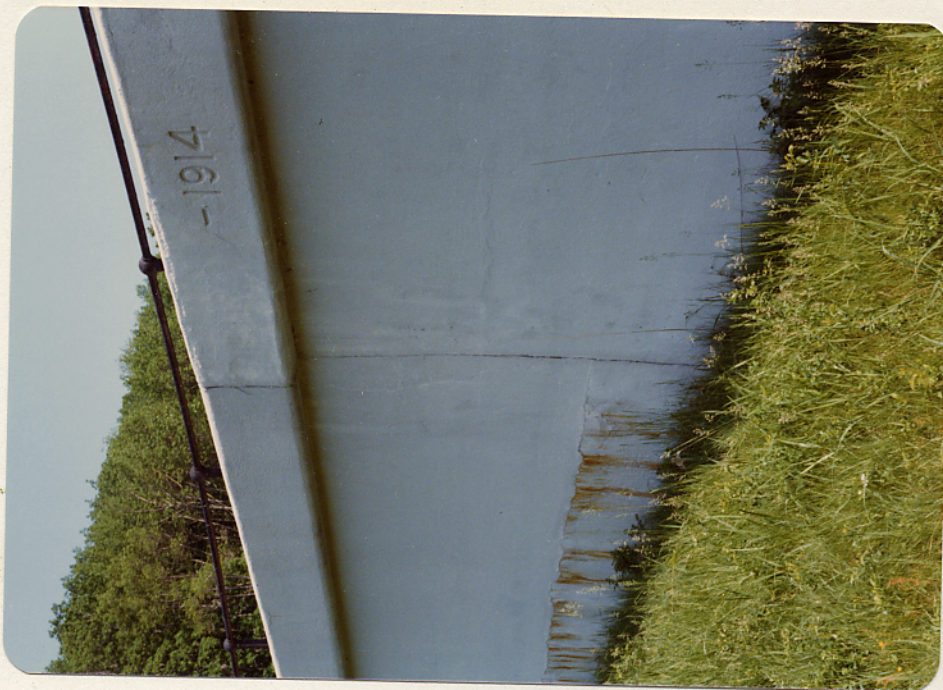
b. Dam - The dam consists of a concrete gravity wall with an earth embankment downstream of the concrete wall. The earth embankment is in good condition showing no indication of deformations, sloughing or erosion with the exception of one location where minor sloughing was noted. No seeps were observed through the embankment slope, at the toe or downstream of the dam. The downstream slope of the embankment is covered with well-maintained grass. The drawings indicate a stone drain placed against the downstream face of the dam at the expansion joints connected to an horizontal drain under the downstream embankment. There was no visual evidence of an outlet for the horizontal drain. The upper end of the drain against the downstream face of the concrete wall does not reach the surface of the downstream embankment crest according to the drawings, and thus the presence of the drain could not be visually verified. Minor seepage was observed at horizontal construction joints and expansion joints at various locations in the downstream face of the dam.

PHOTO NO. 3 - Seepage and staining of downstream face of dam at horizontal construction joint.

1. Expansion joints, and any horizontal construction joints which are presently leaking, should be cleaned out, spalled concrete repaired, and the joints caulked. At present, seepage at horizontal construction joints appears to be minor, but if not repaired, concrete deterioration will progress and seepage will increase.
2. Fallen trees and any other debris should be removed from the low level outlet structure. Any trees in the area which might possibly block the outlet structure in the future should also be removed.
3. Areas of minor sloughing on the downstream slope face should be observed periodically to ascertain that no further sloughing is occurring. Should the problem become worse, areas of the slope subject to the sloughing should be repaired with angular stone to increase slope stability.

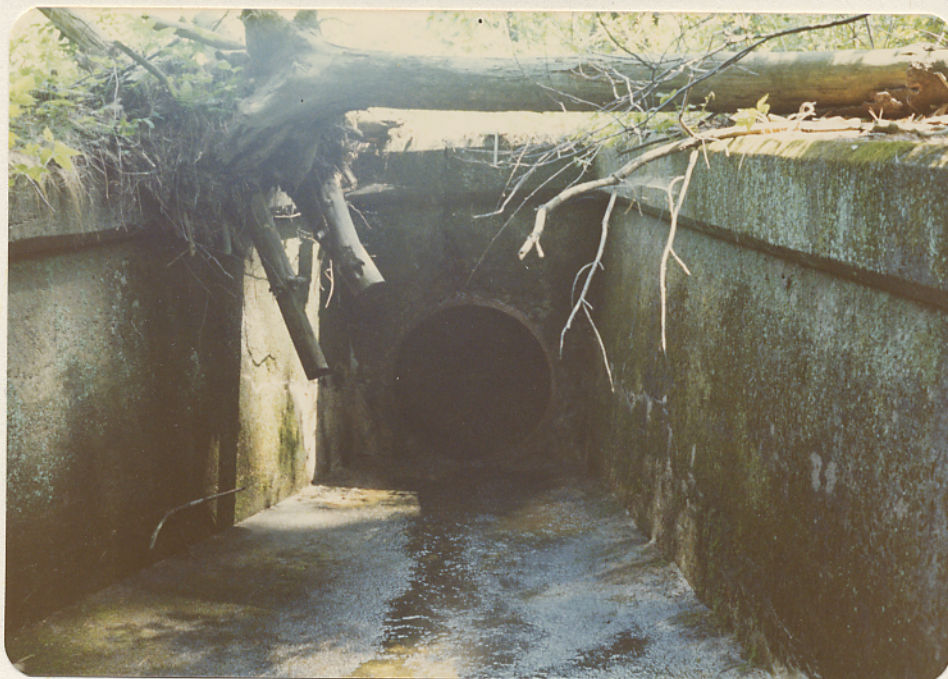
c. Appurtenant Structures - The low level outlet structure has concrete walls which are in good condition. At the time of our inspection, a tree had fallen over the outlet structure.

PHOTO NO. 4 - Low level outlet structure. Note fallen tree.
